HUNTING CREEK DAM

INVENTORY NUMBER NDS MD-58

## PHASE I INSPECTION REPORT

NATIONAL DAM SAFETY PROGRAM

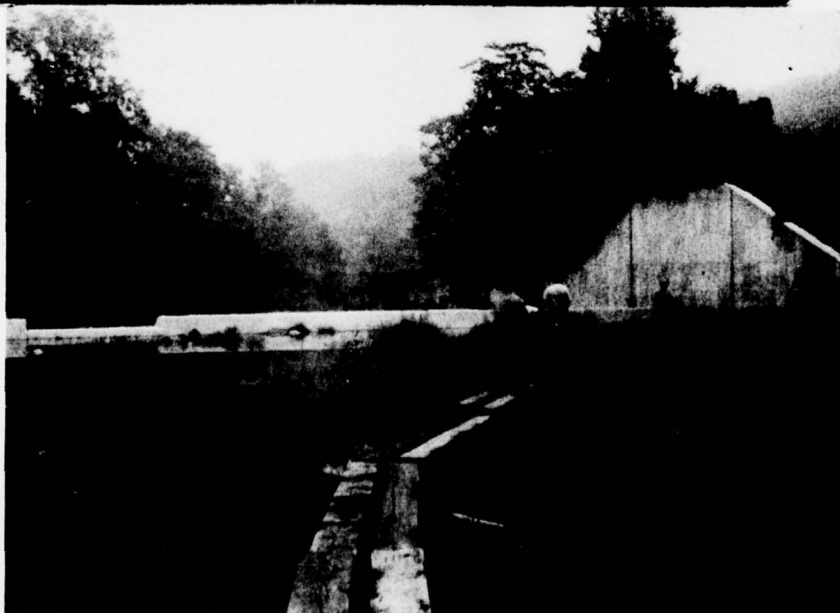
Forebay and  
"Floating" Boom

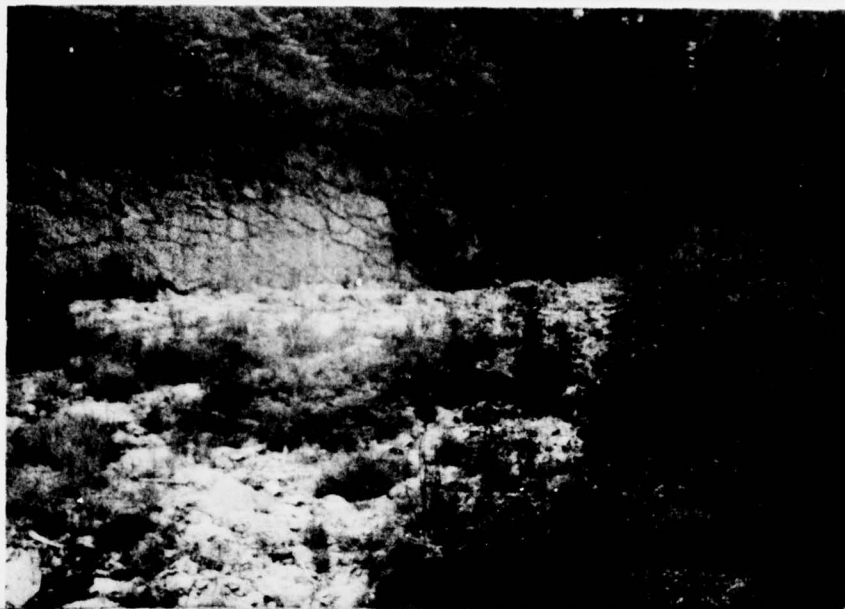
The spillway channel is excavated into natural rock. Its surface is very irregular and provides a natural energy dissipator for the flow. Some brush and weed growth is located in this channel. The stilling basin is a concrete lined basin located at the end of the spillway channel. Erosion of the rough rock surface has partially filled the downstream end of the basin. The concrete walls of the stilling basin appear to be in good condition. Refer to Appendix D, Plate IV.

The spillway outlet channel contains some brush and weed growth and should be cleared. Also loose eroded materials should be removed.

Spillway Channel

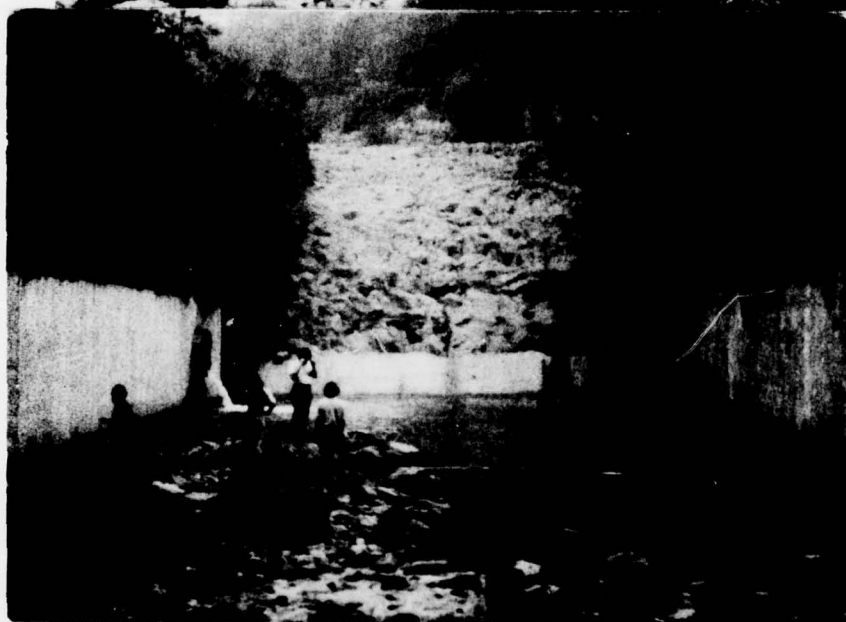
Spillway Basin &  
Spillway Channel

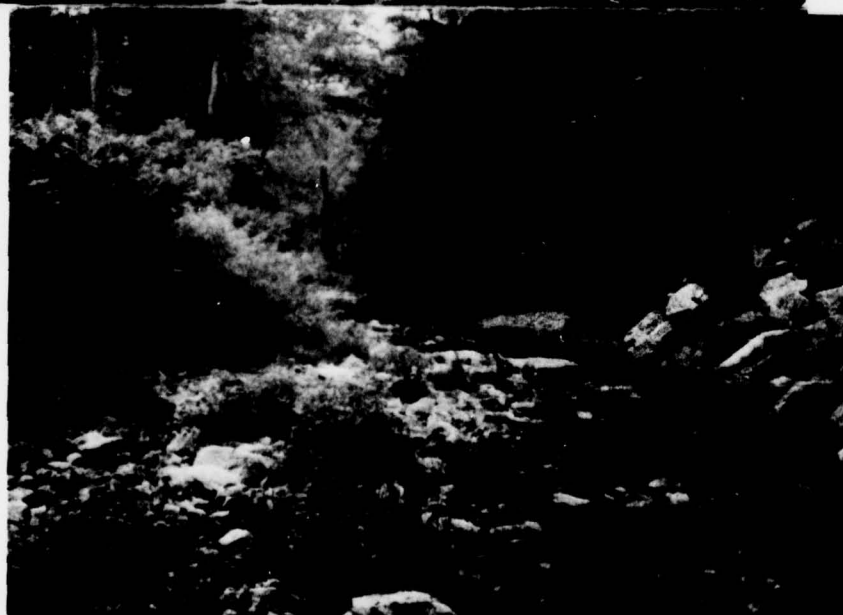
Downstream  
Channel
